Registration Form	SESTER OUT THE SERVICE
1. Name of Property	
historic name Kansas Route 66 Historic District, East of Gal	ena
other names/site number <u>US Highway 66</u>

Kansas Route 66 Historic District, East of Galena Cherokee County, KS

SUMMARY

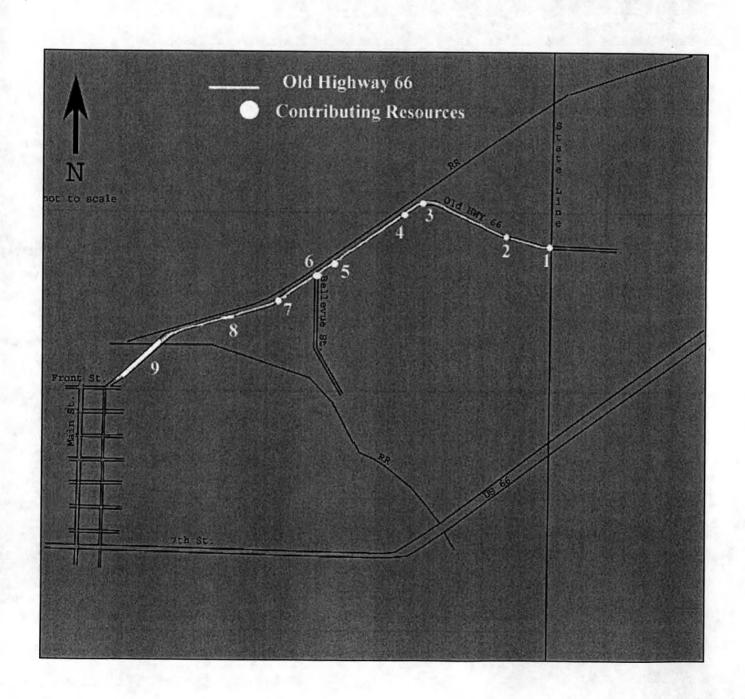
Section Sketch Map Page 10

¹ The sketch map at the end of this nomination shows the locations of the contributing structures within the historic district.

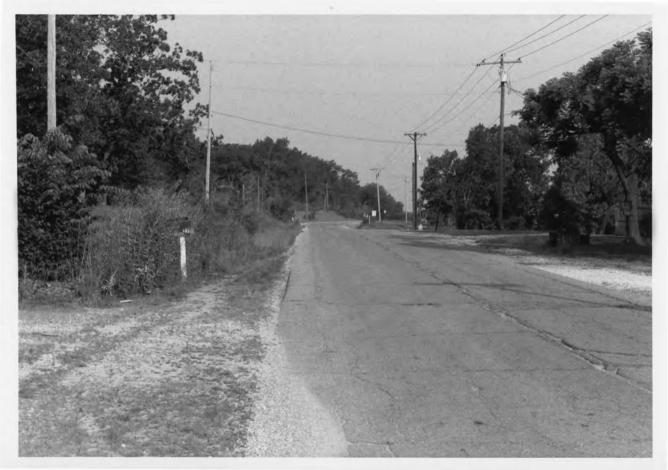
- 1) Route 66, view looking west from the state line.
- 2) Route 66, view looking northeast approximately 0.35 miles west of the state line.
- 3) Route 66, view looking west approximately 0.5 miles west of the state line. The access road to the Eagle-Picher facility is visible on the right and the intersection of Bellevue Street is visible on the left. Culvert 5 is visible in the foreground.

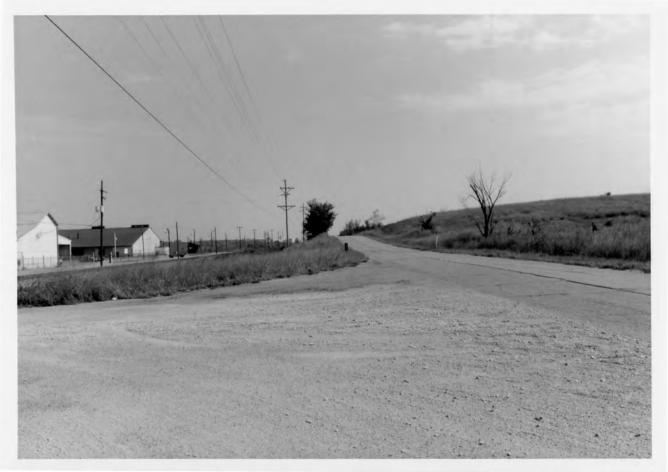
- 4) Route 66, view looking east approximately 0.6 miles west of the state line. The access road to the Eagle-Picher facility is visible in the foreground. Culvert 5 is visible at the middle of the photo.

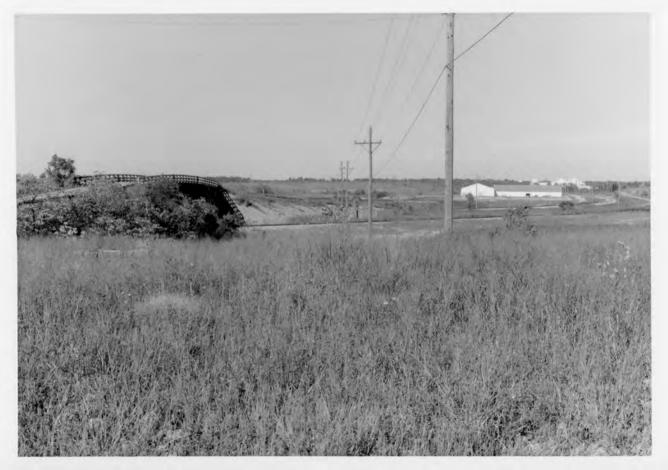
- 5) Route 66 viaduct and road, view looking east approximately 1.2 miles west of the state line. The Eagle-Picher facility is visible in the background.

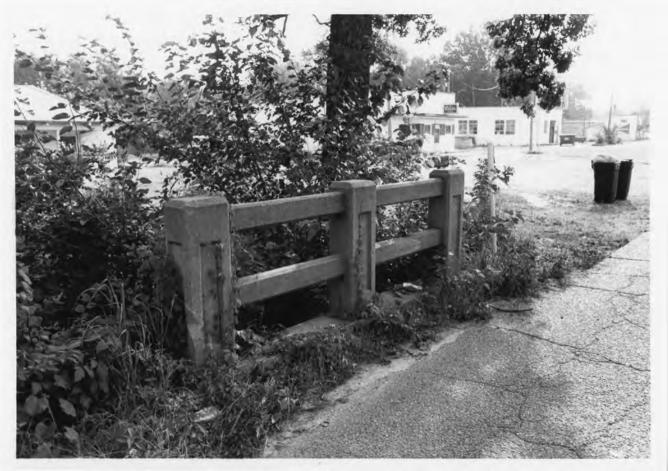
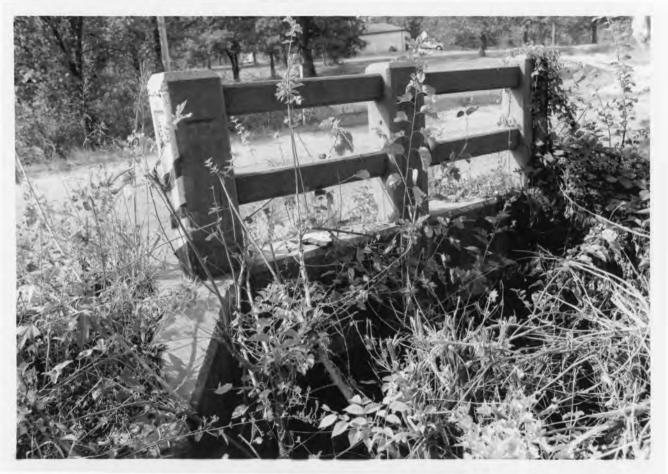
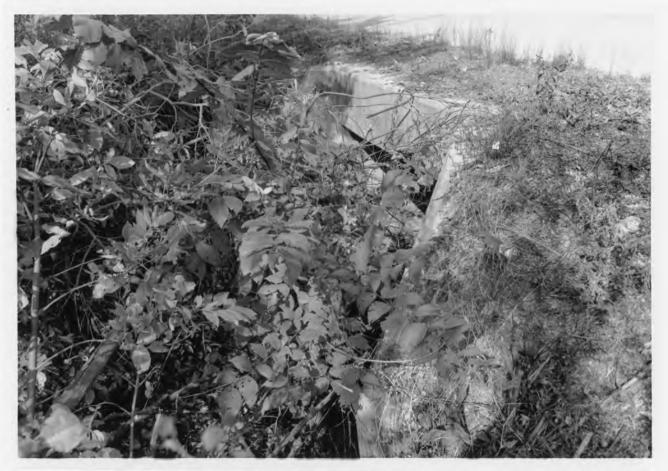
Culvert 1, at the Missouri state line (0.0), includes elements on the north and south sides of the road. The culvert lintel is 8 feet long and 15 inches wide at the edge of the street. Supporting the culvert lintel are retaining walls that extend outward 75 inches. From the level of the pavement, the lintel is 22 inches high. Below the lintel the rectangular culvert opening is 56 inches tall and 96 inches wide. On the south side of the road, the culvert has a typical two-bay railing. The three posts rising from the lintel are 40 inches high and 12 inches square. Centered on the lintel, the posts are set 42 inches apart. Connecting the posts are pairs of 6-inch-tall rails set 12 inches apart. This culvert structure and railing are in good condition, although the middle post has some spalling and exposed rebar. On the north side of the road, the upper railing is missing.

- 6) Culvert 1, north side of road, view looking northeast.
- 7) Culvert 1, north side of road, view looking southwest.
- 8) Culvert 1, south side of road, view looking northwest.

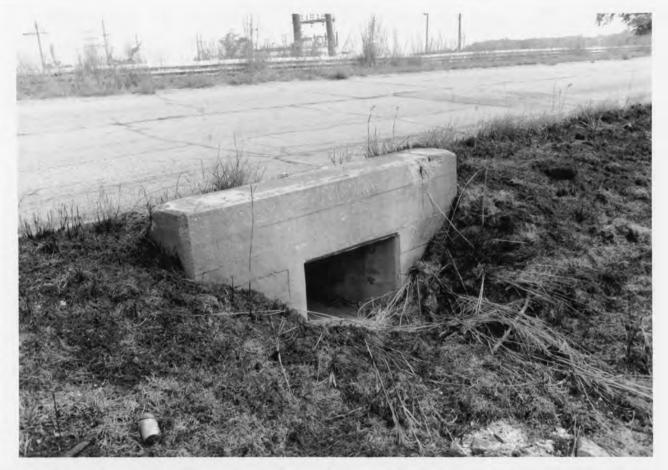
Culvert 3, 0.3 miles west of the state line, includes one element on the south side of the road. The culvert lintel is 72 inches long and 15 inches wide at the edge of the street. From the level of the pavement, the lintel is 22 inches high. Below the lintel the rectangular culvert opening is 24 inches tall and 36 inches wide. This culvert has neither flanking support elements nor a railing, although the anchors for two posts are visible on top of the structure. The structure has some chipping and spalling along the top edge. A small bit of rebar is visible on the south side near the top. This culvert structure is otherwise in good condition.

- 12) Culvert 3, south side of road, view looking northeast.
- 13) Culvert 4, south side of road, view looking north.
- 14) Culvert 4, north side of road, view looking southwest.

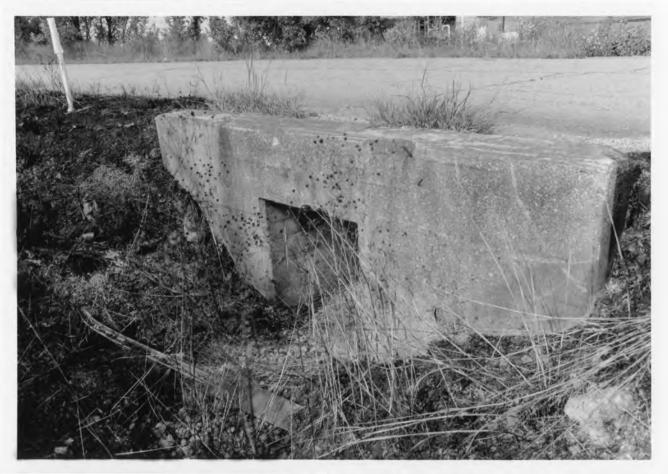
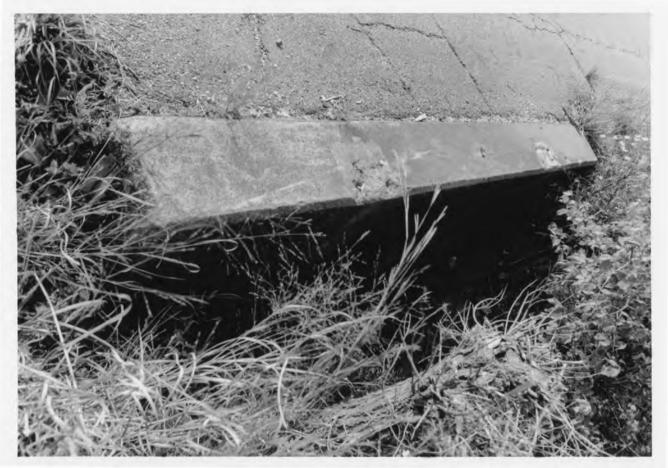
Culvert 4, 0.385 miles west of the state line, includes elements on both the north and south sides of the road. The lintel of this culvert is 147 inches long and 15 inches wide at the edge of the street. From the level of the pavement, the lintel is 22 inches high. Below the lintel the rectangular culvert opening is 36 inches tall and 36 inches wide. Neither portion of this culvert retains a railing, although the anchors for two posts are visible on top of each structure. Both lintels have minor chipping along the top edge and a small piece of rebar is visible from the south side of the road. On the north side of the road, the pavement has pushed the top of the culvert away from the roadbed, although it remains secure in its tilted position. Otherwise, the culvert is in good condition.

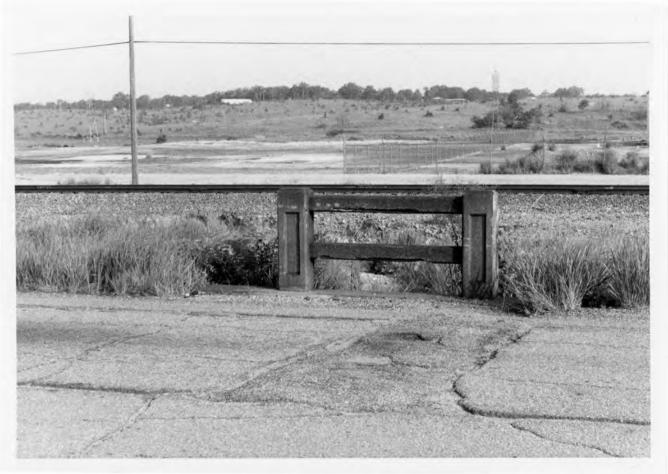
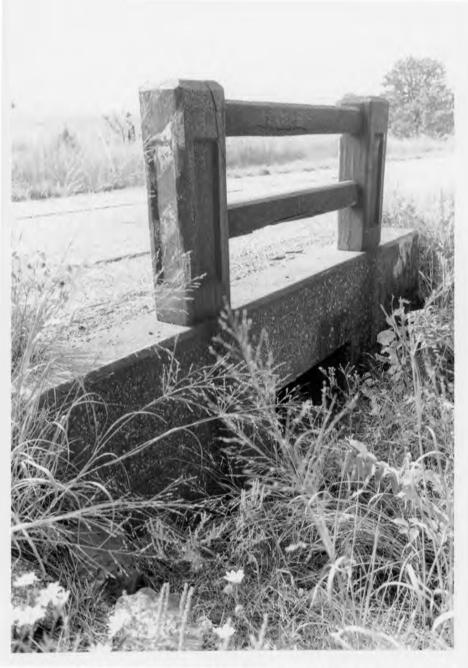
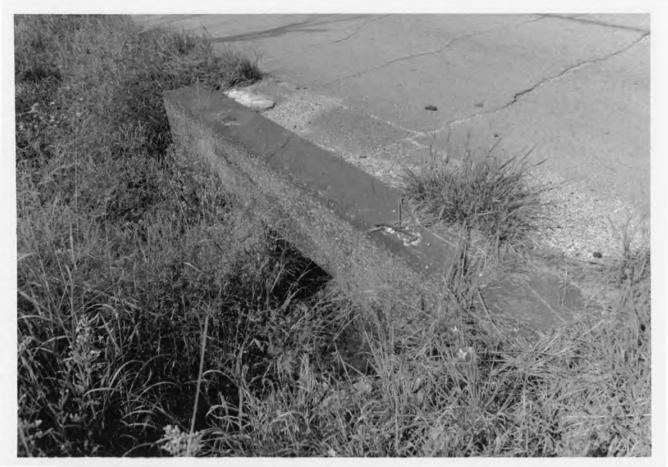
Culvert 5, 0.6 miles west of the state line, includes elements on both sides of the road. The culvert lintel is 147 inches long and 15 inches wide at the edge of the street. From the level of the pavement, the lintel is 22 inches high. Below the lintel the rectangular culvert opening is 24 inches tall and 36 inches wide. The north end of the culvert retains its one-bay railing. The two posts rising above the lintel are 40 inches high and 12 inches square. The posts are centered on the lintel and are set 60 inches apart. Connecting the posts is a pair of six-inch-tall rails set 12 inches apart. The railing is generally in fair condition. There is concrete spalling at the bottom of both rails, the east post has a large crack toward the top, and there is evidence that the west post may spall as well. The railing is missing from the south culvert, although anchors for the posts are visible. This structure is otherwise in good condition.

- 15) Culvert 5, north side of road, view looking north.
- 16) Culvert 5, north side of road, view looking southwest.
- 17) Culvert 5, south side of road, view looking east.

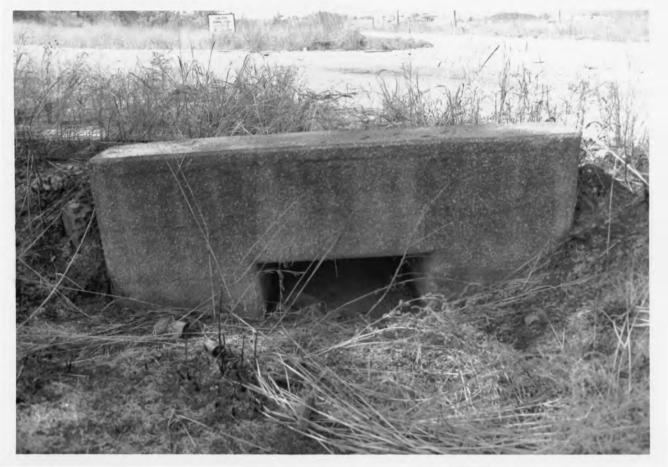
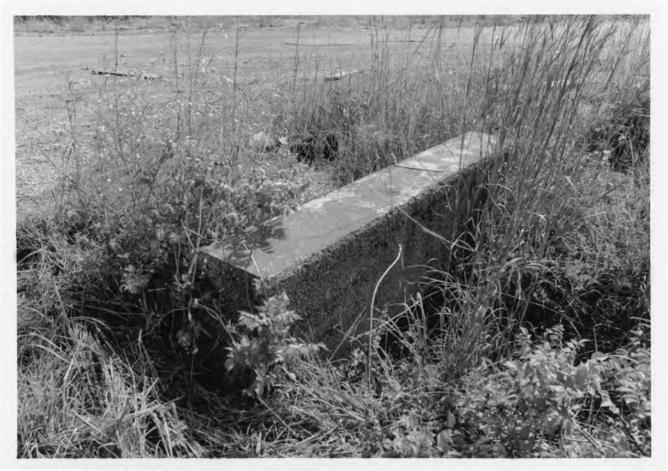
Culvert 6, at the intersection of Route 66 and Bellevue Street, includes elements on the southeast and southwest corners of the intersection. The culvert lintel is 72 inches long and 15 inches wide at the edge of the street. From the level of the pavement, the lintel is 22 inches high. Below the lintel the rectangular culvert opening is 36 inches wide. The openings are 18 inches tall on the southwest structure and 9 inches tall on the southeast structure. The structures are in good condition with few chips or spalls.

- 18) Culvert 6, southeast corner, view looking west.
- 19) Culvert 6, southwest corner, view looking east.
- 20) Culvert 7, south side of road, view looking west.

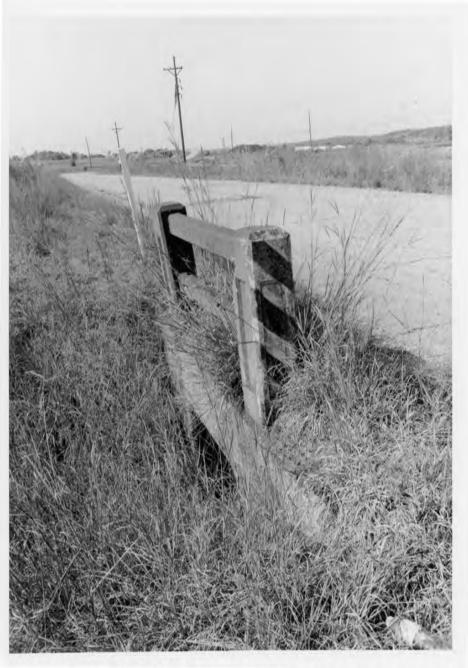
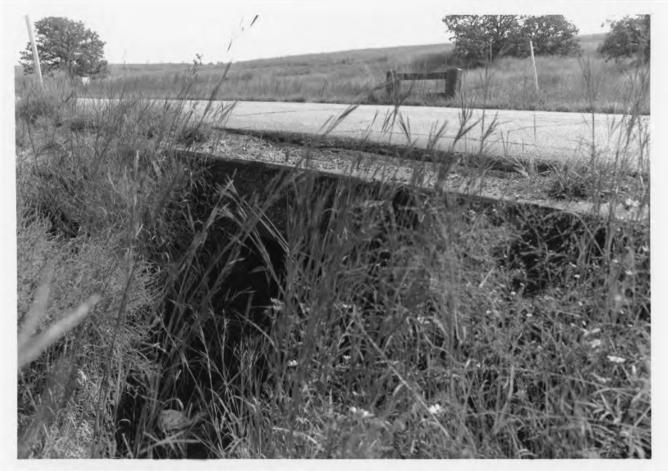
Culvert 7, 0.65 miles west of the state line, includes elements on both sides of the road. The culvert lintel is 147 inches long and 15 inches wide at the edge of the street. From the level of the pavement, the lintel is 22 inches high. Below the lintel the rectangular culvert opening is 24 inches tall and 36 inches wide. The south end of the culvert retains its one-bay railing. The two posts that rise from the lintel are 40 inches high and 12 inches square. The posts are centered on the lintel and are set 60 inches apart. Connecting the posts is a pair of six-inch-tall rails set 12 inches apart. The railing is in good condition, exhibiting only minor chips. The south culvert's railing is missing, although anchors for the posts are visible. This structure is otherwise in good condition.

- 21) Culvert 7, north side of road, view looking southeast.
- 22) Triple Culvert, north side of road, view looking southeast.
- 23) Triple Culvert, south side of road, view looking northeast.

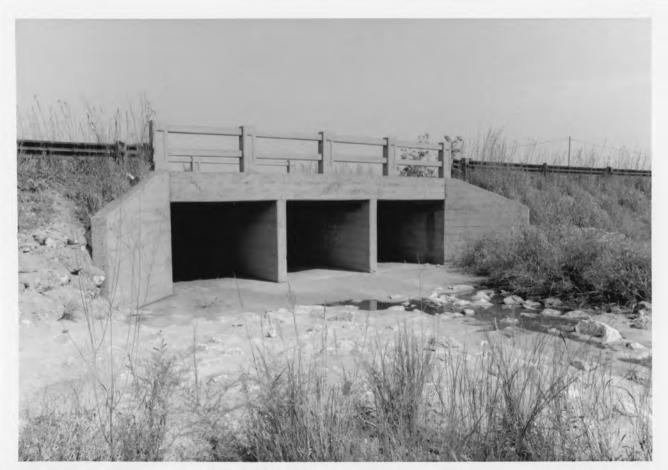
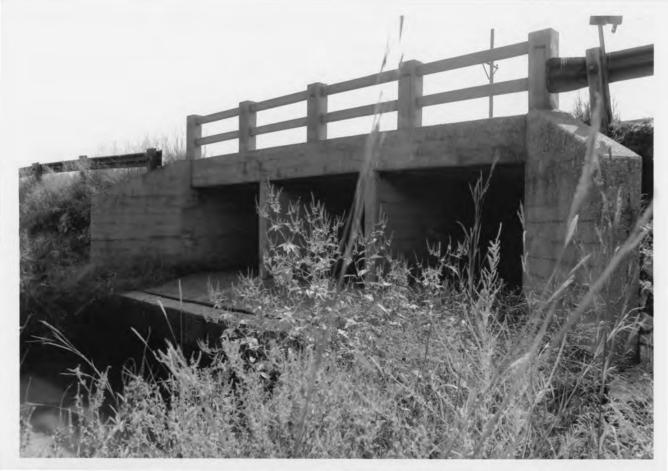
The large triple culvert, 0.8 miles west of the state line, includes elements on both sides of the road. This large drainage structure is 137 inches long and 15 inches wide at the edge of the road. Angled retaining walls extend 90.5 inches on each side of the culvert opening. From the level of the pavement, a continuous 22-inch-tall lintel runs above the three-bay opening. Each bay is 42 inches wide and 72 inches tall, with a 5½-inch-wide wall separating the adjacent bays. The dividing walls run the full depth of the culvert below the road. A concrete apron, level with the base of the culvert, fills the space between the retaining walls. The north opening retains its original apron, which is six feet wide and two feet thick. The south apron, which has been repoured, is eight feet wide and slopes gently to ground level. The drainage channel on the south side of the culvert also appears to be partially covered with concrete as well, probably when the new apron was installed. A four-bay railing spans the width of the lintel. Each post is 38 inches tall, 12 inches wide, and nine inches deep. Connecting the posts are pairs of rails that measure six inches tall and 64 inches wide. The ground slopes steeply beyond the edge of the road and modern metal guardrails flank the culvert, abutting the historic railings.

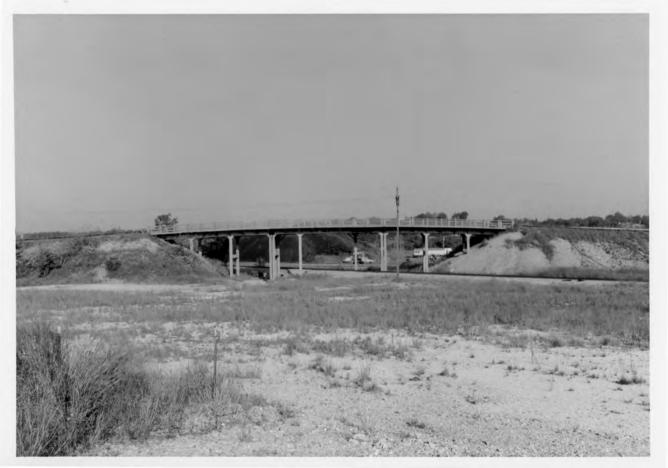
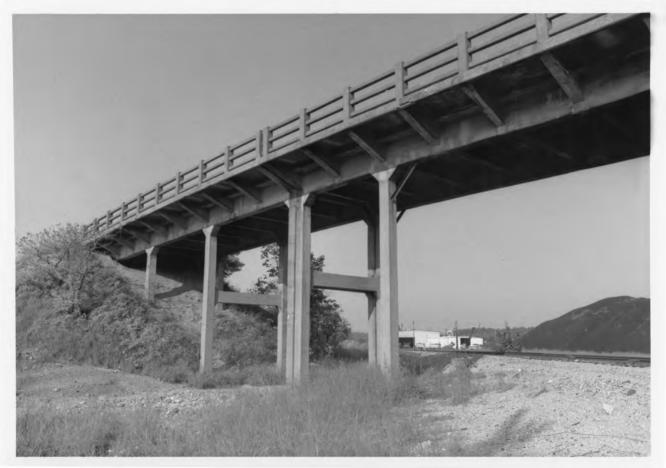
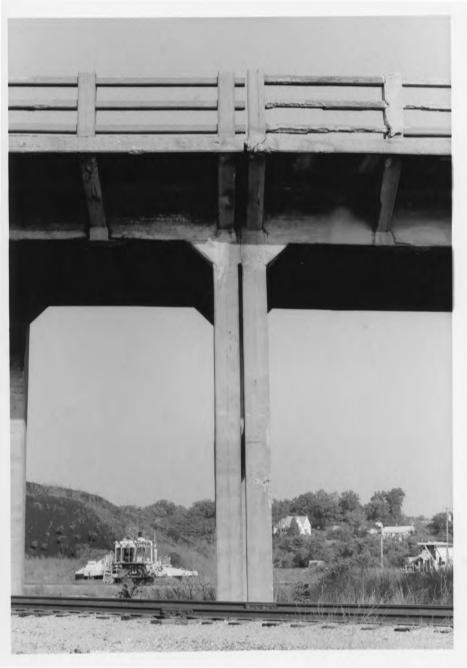
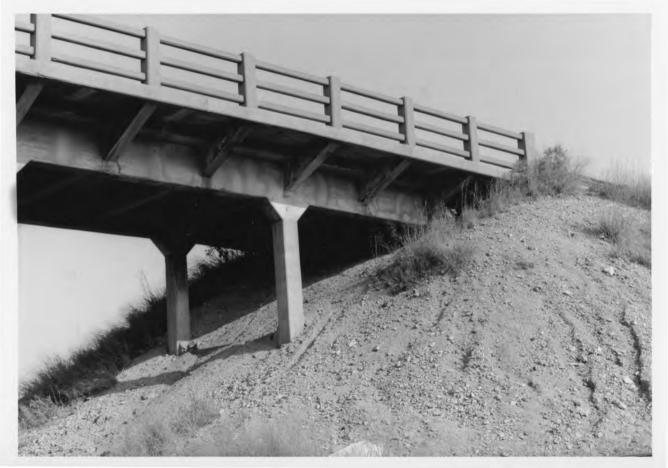
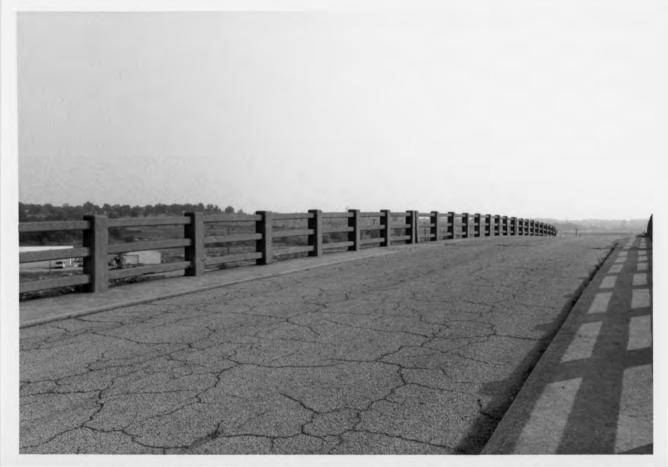
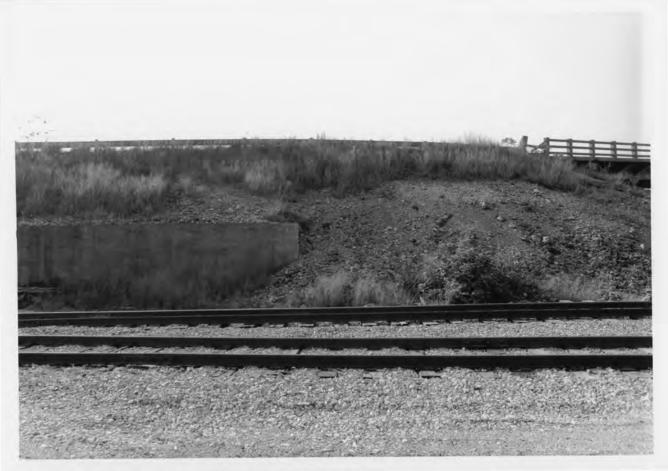
length that curves gently as it carries the two-lane road across the tracks of the Missouri Kansas and Texas Railroad (MKT). The steel girder bridge structure is encapsulated in concrete. Its central span is 65.9 feet long with approach spans at each end. A pair of steel girders runs the length of each span, connected by perpendicular floor beams at regular intervals. Knee braces on the outside of the girders extend the floor beams to support the sidewalks cantilevered on either side of the roadway. The main span rises 21 feet above the railroad tracks below. Supporting the ends of the central span and the inner ends of the approach spans are pairs of square posts that are connected at the center to form an "H." The tops of the posts flare slightly to form trapezoidal caps. Supporting the center span are additional single posts: one supporting the south girder just east of the west end of the span; one supporting the north girder just west of the east end of the span. Providing these posts with an additional connection to the girder are exposed steel angle braces. Short single posts are also found at the center of the approach spans where the ground slopes up to the elevated roadway. An asphalt road surface covers the cast-in-place concrete deck. The road is 20 feet wide with 5-foot-wide concrete sidewalks on either side. Railings run along either side of the viaduct next to the sidewalks. The railings are composed of 12-inch square posts connected by three parallel rails.

The Route 66 Viaduct is in generally fair condition. It received a rating of "Substandard" on its 2002 Kansas Department of Transportation Bridge Inspection Report. The concrete structure has some spalling and the steel rebar is visible in some locations, particularly on the posts, knee braces, and railing. Some of the damage is the result of vehicular collisions.

- 24) Viaduct, view looking northwest.
- 25) Viaduct, west abutment, view looking west.
- 26) Viaduct, view looking northwest.
- 27) Viaduct, east abutment, view looking north.

- 28) Viaduct, east approach, view looking south.
- 29) Viaduct, deck and railing, view looking northeast.
