National Register of Historic Places
Registration Form

historic name Route 66 Rural Historic District: Laguna to McCarty's

The Route 66 rural historic district extending westward along Route 66 from Laguna to McCarty's covers an area of approximately 216 acres and includes a 17.7 mile segment of former Route 66, now SR 124, and seven buildings, all dating to the period of significance. The road section has a chip seal surface and contains several features characteristic of 1930s road building in New Mexico including numerous concrete box culverts, guardrails, slope and bank cuts, and cross-section template. The buildings are located at two roadside trading posts that between them offered several roadside services including gas, food, lodging, towing and auto repairs. The buildings are a part of two rural service complexes whose spatial organization and regional architectural styles are characteristic of roadside businesses in New Mexico during the late 1930s. Some of the buildings no longer function as they did historically, but all of them retain a high degree of historic integrity. Together with the road linking them, they convey a strong feeling of highway travel in the 1930s

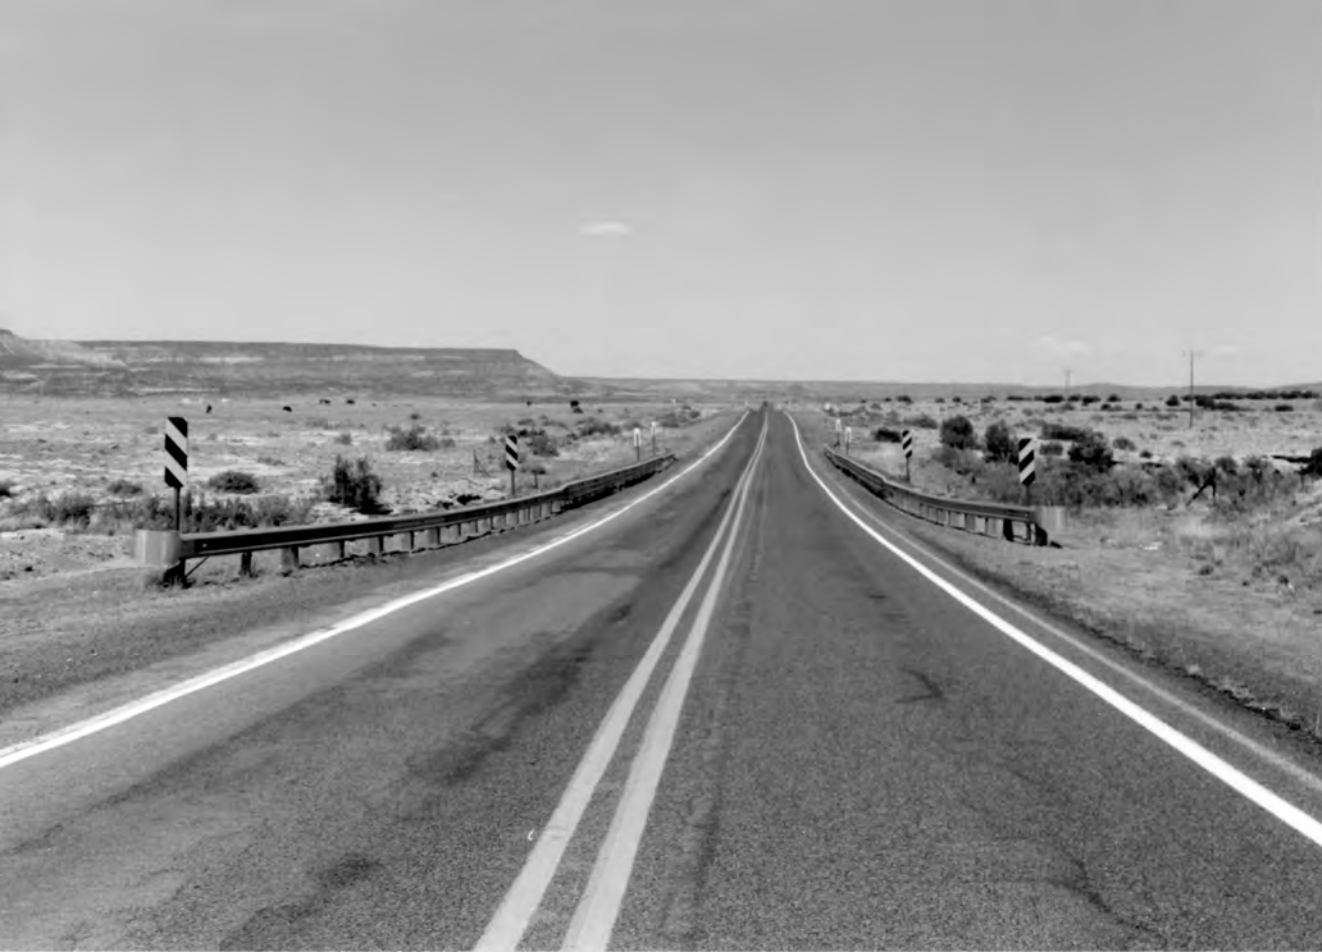
1
SR 124 (Rt 66), Rt. 66 Rural Historic District: Laguna to McCarty's
Cibola Cty. N.M.

- #1 Route 66; now SR 124; 1937; twenty-four ft. wide chip seal surface; multiple concrete box culverts; four substantial slope or bank cuts. Alterations include guardrail replacements. Ill. #1, 2.
- #2 Budville Trading Company; Southwest Vernacular; 1938; one-story; low-hipped composition shingle roof over store with a pitched roof over the residential portion to the rear; decorative log posts and beam frames divide the facade into three bays containing double-hung, fixed and metal casement windows covered with wood screens; principal signs on the upper facade and over the service lane between the building

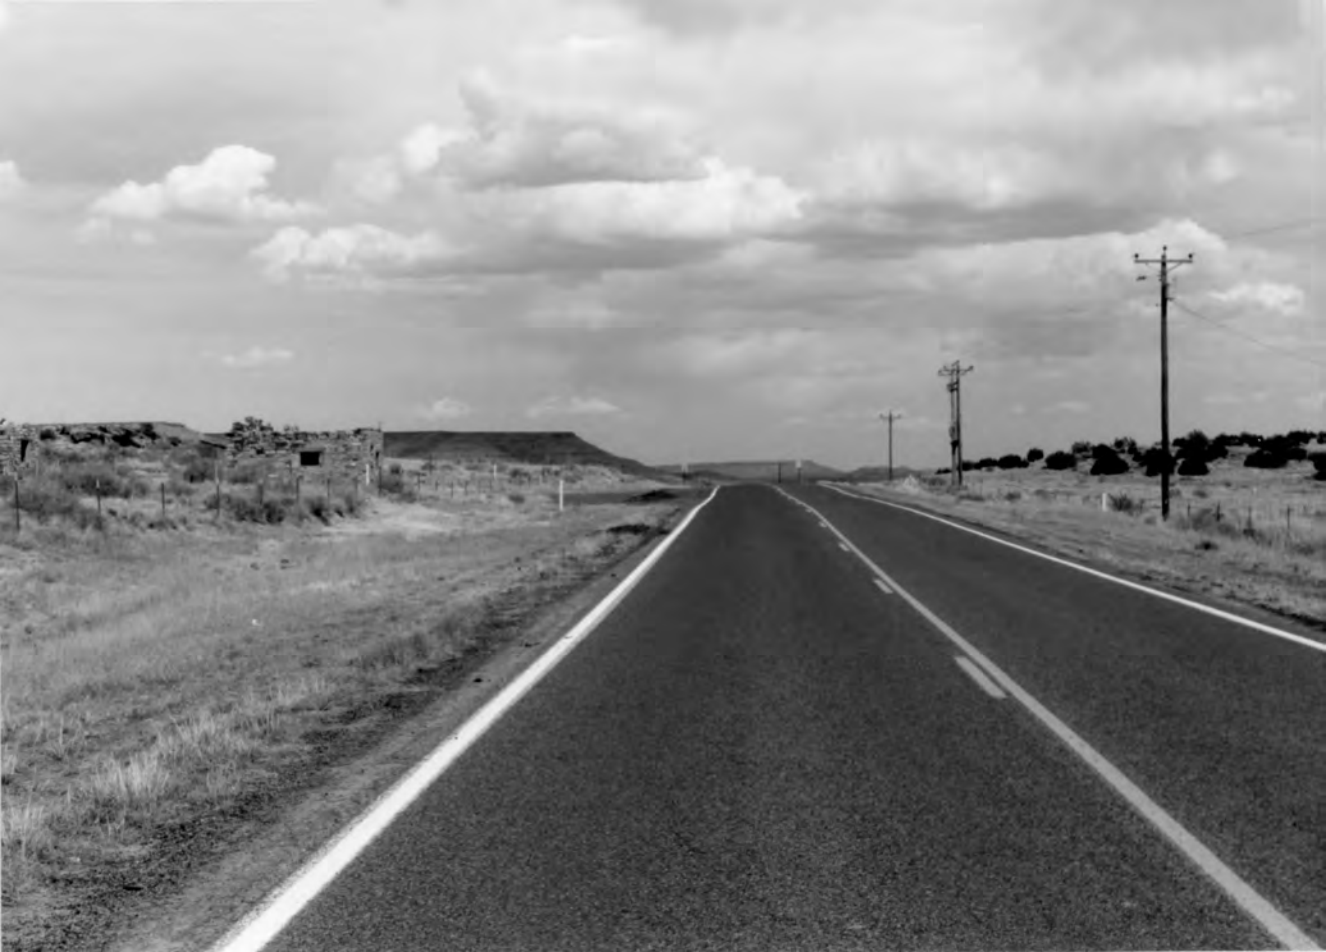
2

SR 124 (Rt 66), Rt. 66 Rural Historic District: Laguna to McCarty's
Cibola Cty, N.M.

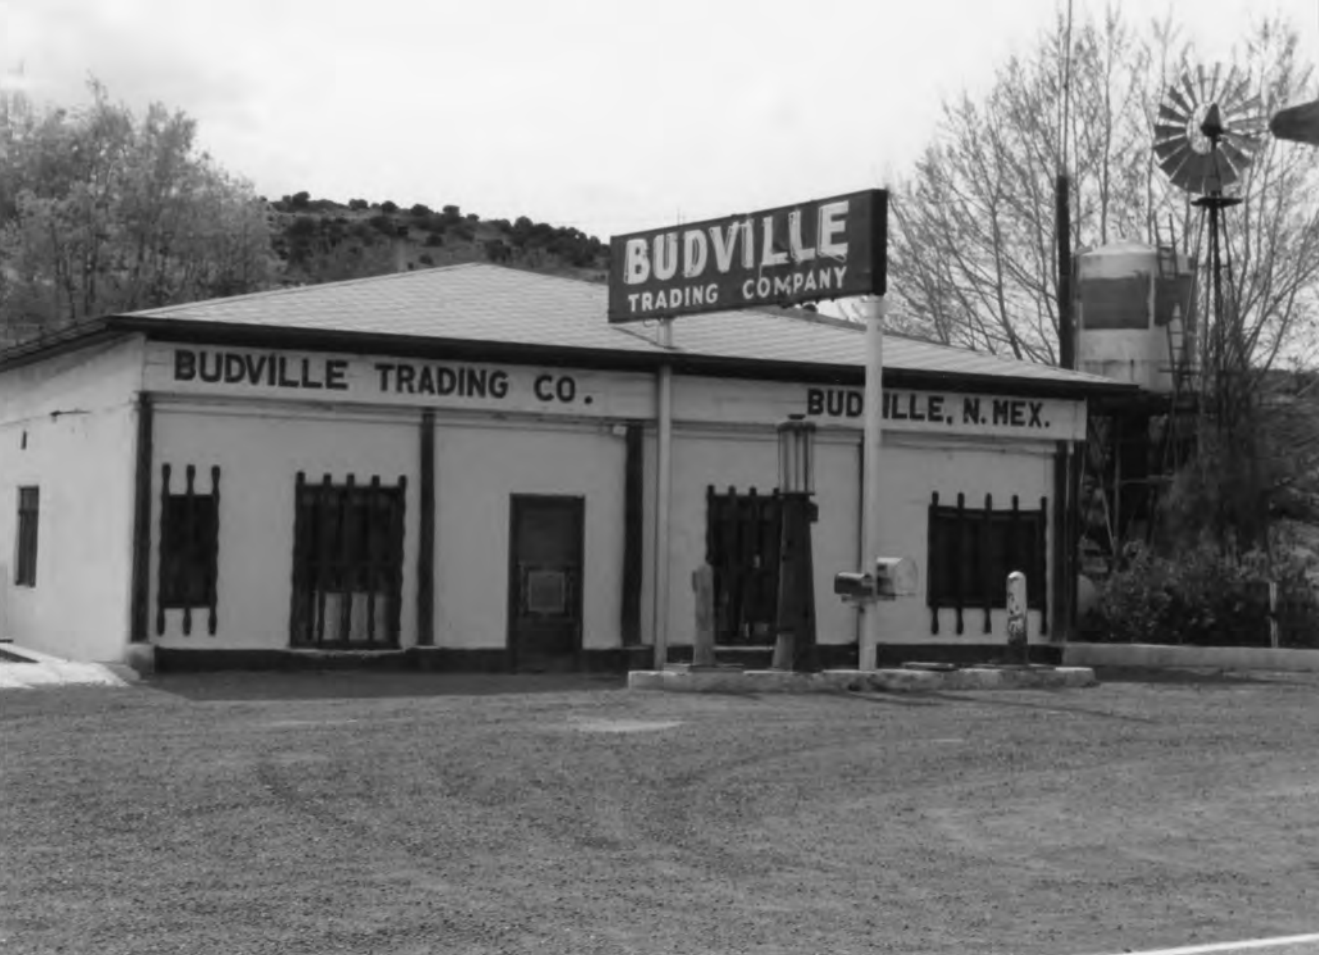
3

- and the concrete pump island; a ramp for servicing cars lies just to the east of the building with its piers built into the hillside. Alterations include a small concrete block storage shed to the east and the hipped roof. Ill. #3.

Budville Trading Co., Rt. 66 Rural Historic District: Laguna to McCarty's
Cibola City, NM

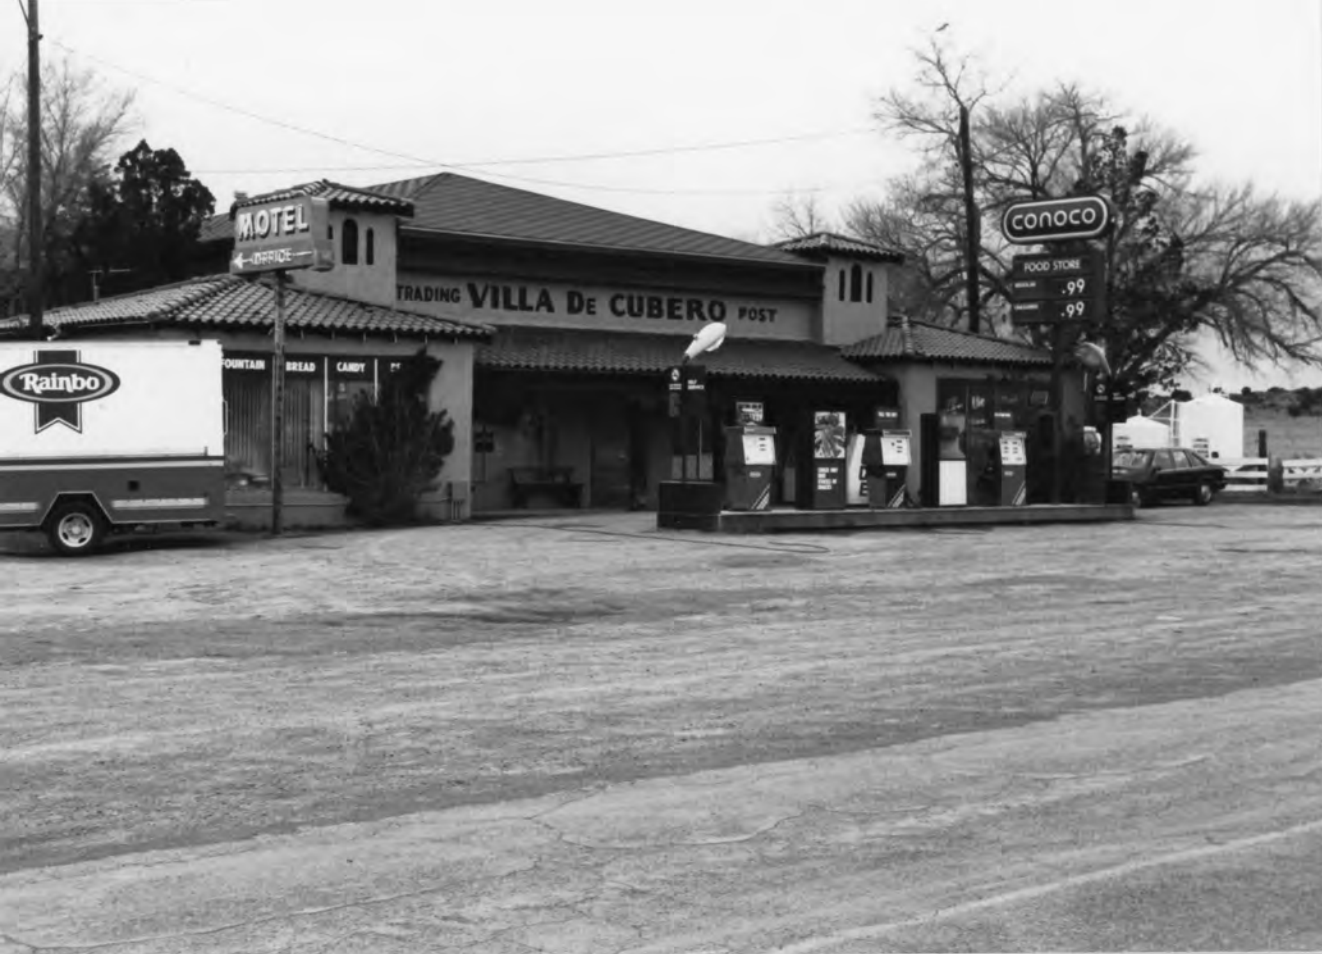
4

- #3 Villa de Cubero; Mediterranean Revival; 1936; one story trading post; brown stucco over adobe; hipped and shed tile roofs; symmetrical facade includes towers and flanking rooms with large commercial windows; recessed central portal with shed roof and wood post supports with corbels; double wood frame commercial doors; heavy wood sliding door at rear warehouse entry; horizontal fixed windows along upper sides; pump island with sign; additional signs on metal pole and facade frieze. Ill. #4.

Villa de Cuervo Trading Post, Rt. 66 Rural Historic District: Laguna to Montezuma

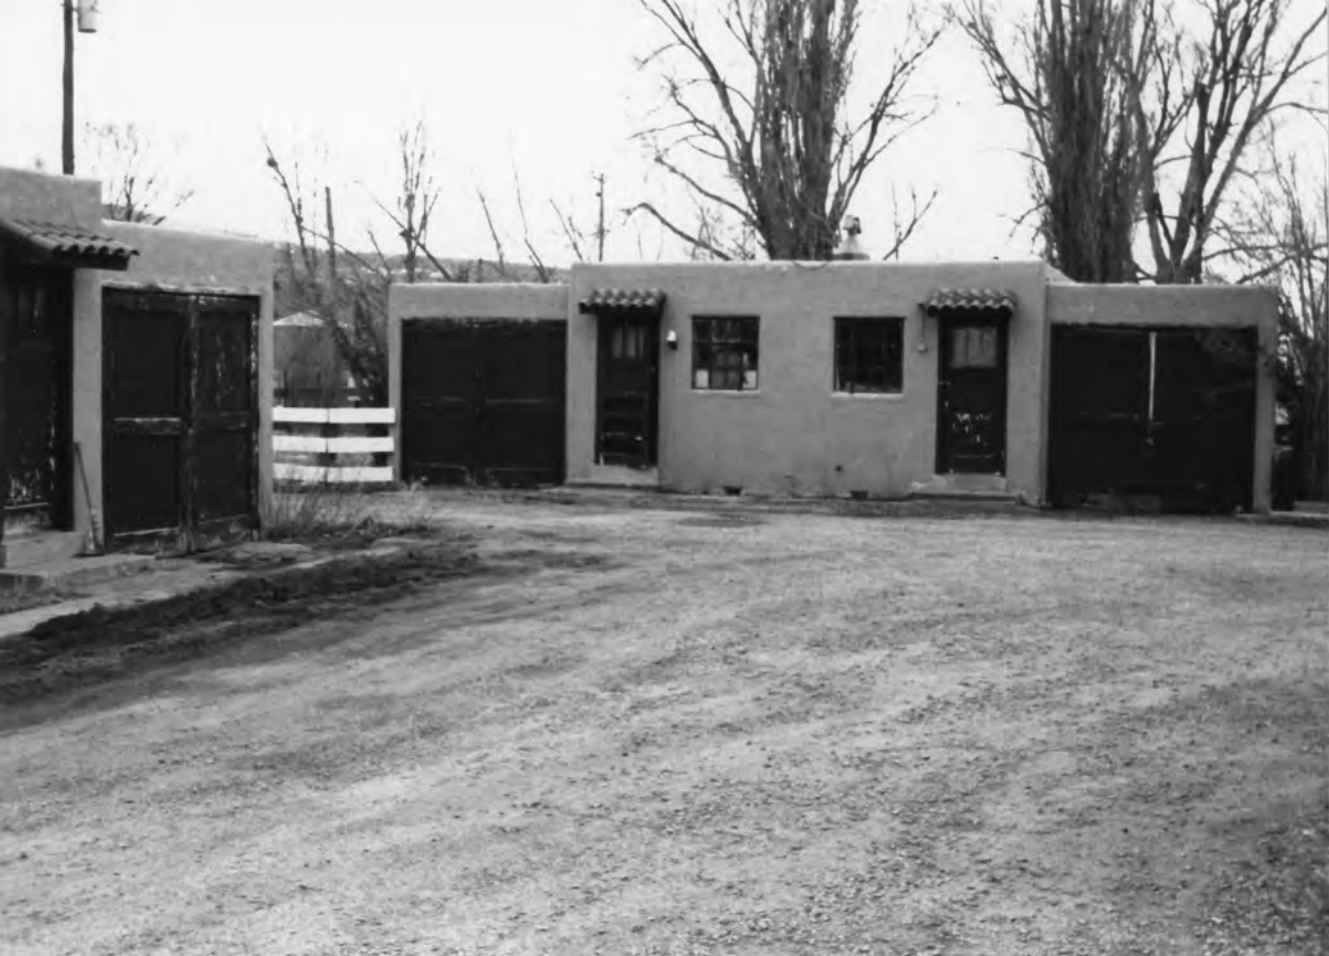
5

- #5 Southeast corner duplex cabin; Southwest Vernacular; 1936; one-story; flat roof with parapet; tile hoods over entries; metal casement windows; wood panel doors with three lights; flanking garages with double wood doors. Ill. #5

Cabins at Villa de Cuero Trading Post, Rt. 66 Rural Historic District:
Laguna to McCarty's 1
